Report No. FAA-SS-73-10

**SST Technology
Follow-On Program-Phase II**

**DEVELOPMENT AND EVALUATION
OF FUEL TANK SEALANTS**

FINAL REPORT
Task II

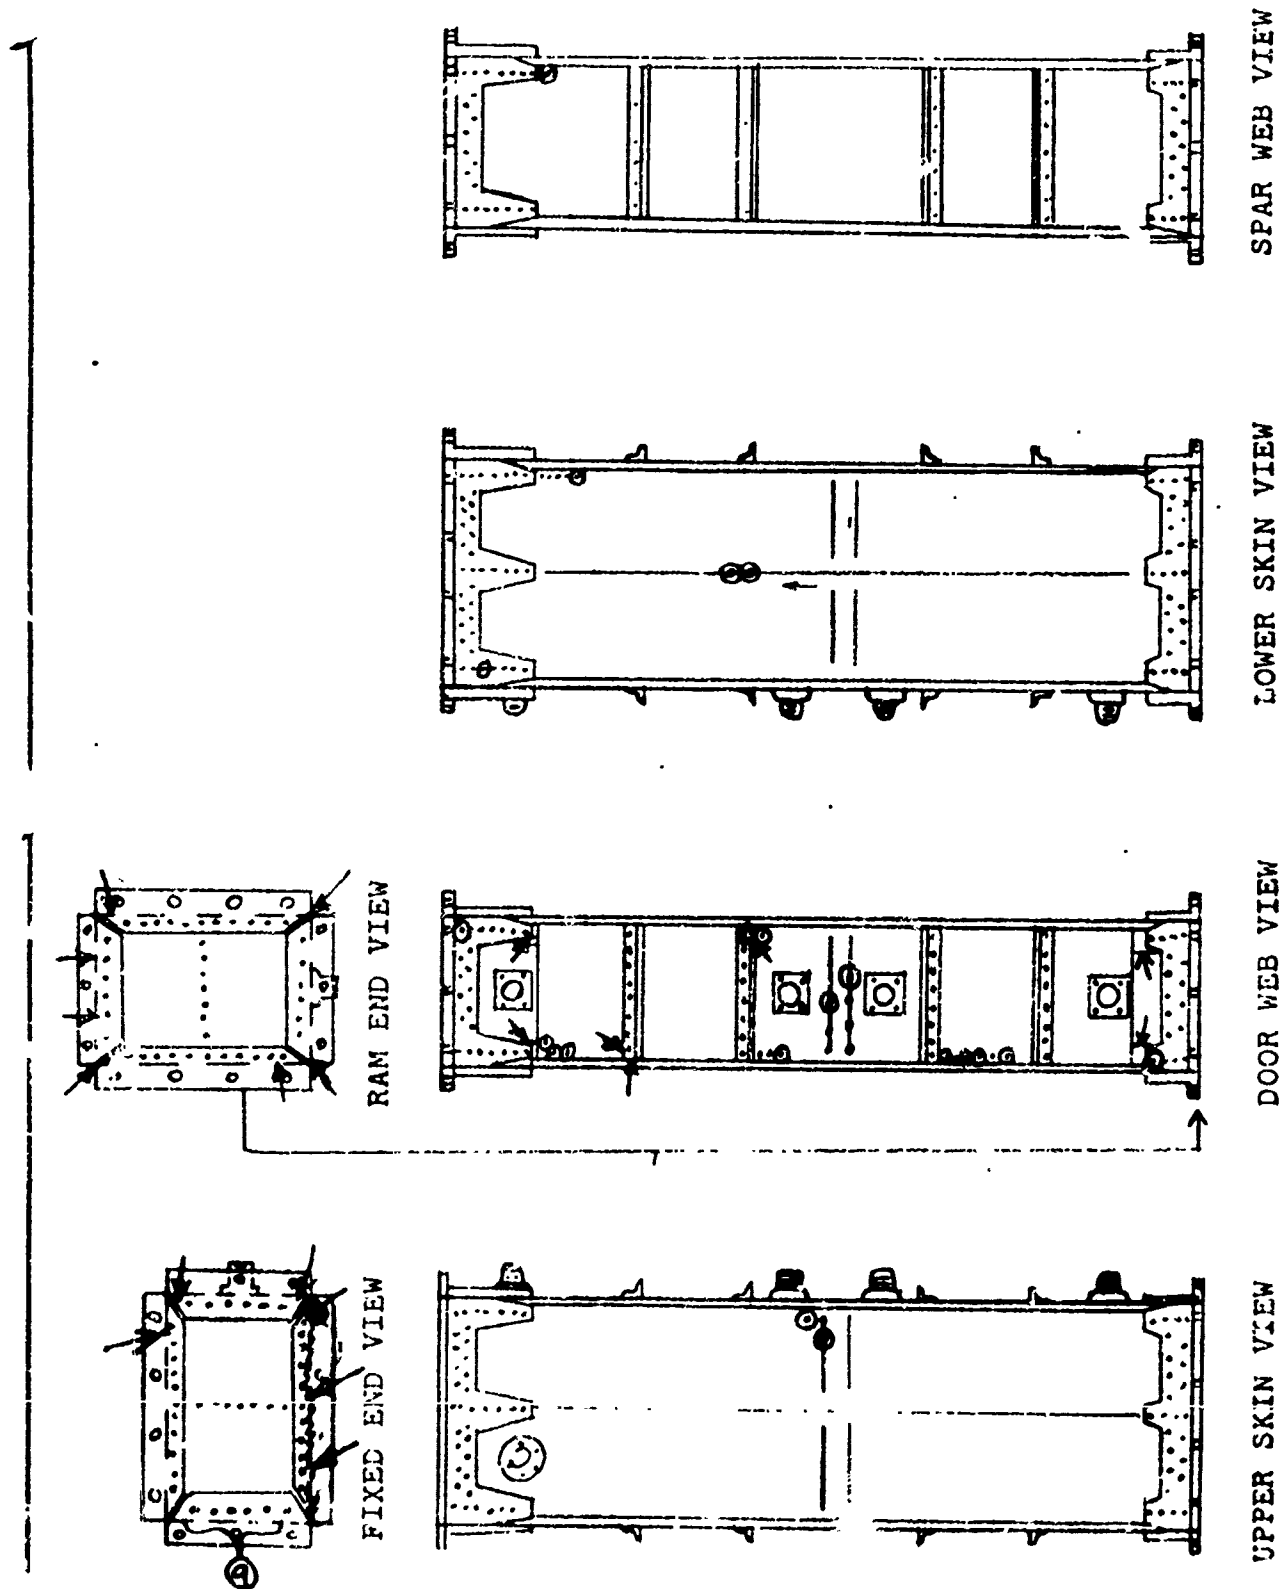
TANK NO. 2 - LEAKAGE AFTER 524 HOURS ENV. CONDITIONING
AT 415-441 OF.

LEAKS MARKED WITH CIRCLES (FASTENER LEAKS) OR ARROWS (SEAM LEAKS)
LEAK TESTED 4-3-70

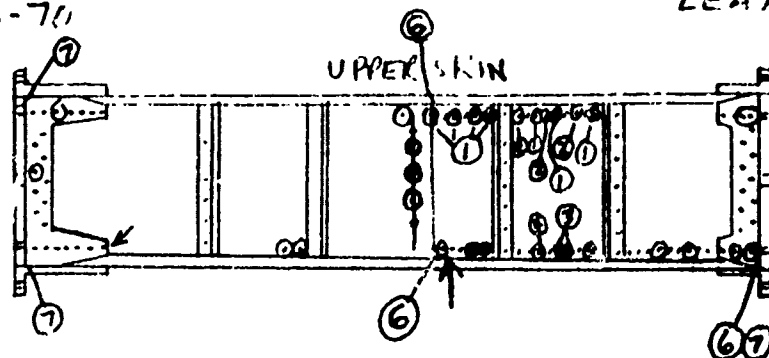
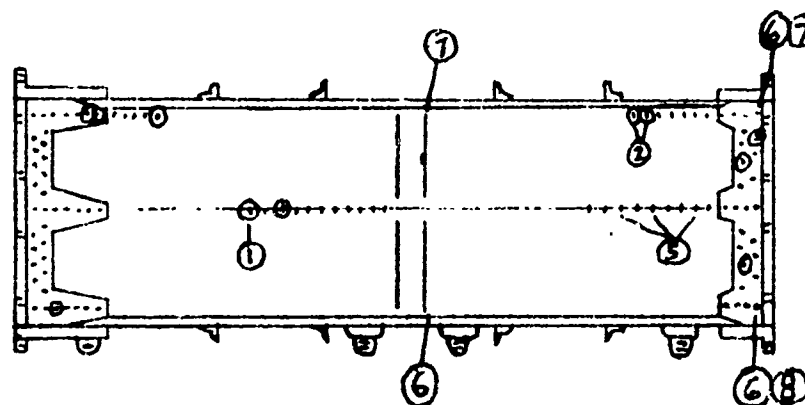
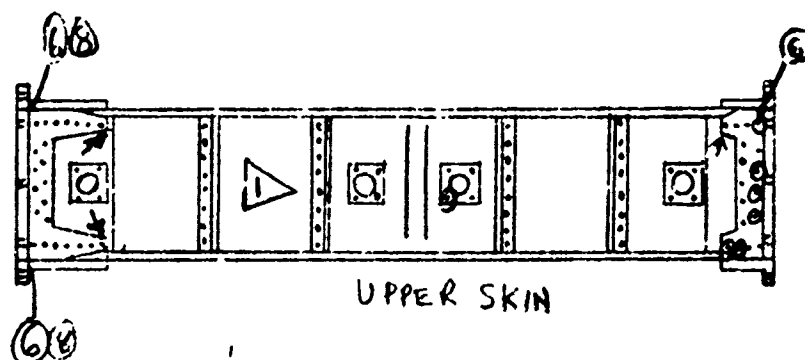
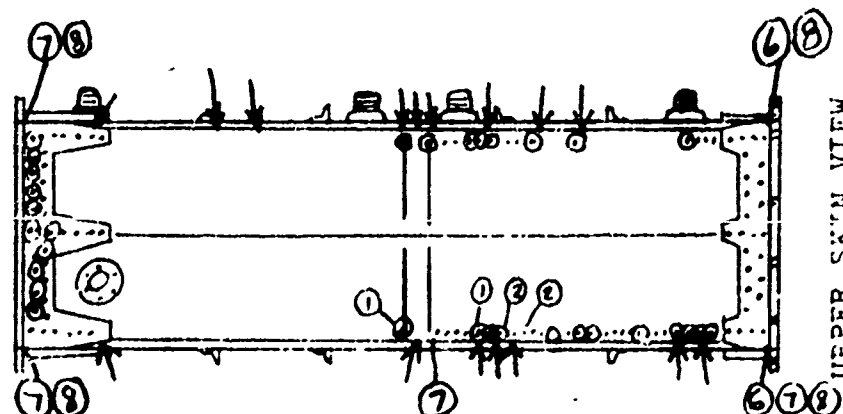
TANK NO. 2 - LEAKAGE AFTER 524 HOURS ENV. CONDITIONING
PLUS 510 LOAD CYCLES AT 426-441°F.

LEAKS MARKED WITH CIRCLES (FASTENER LEAKS) OR ARROWS (SEAM LEAKS)
 LEAK TESTED 3-17-70

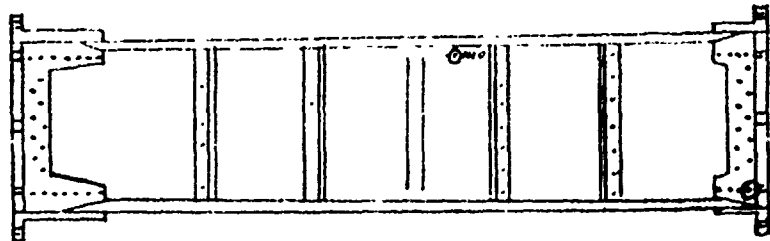
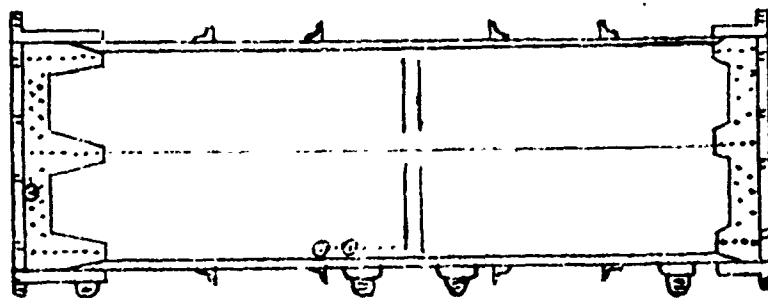
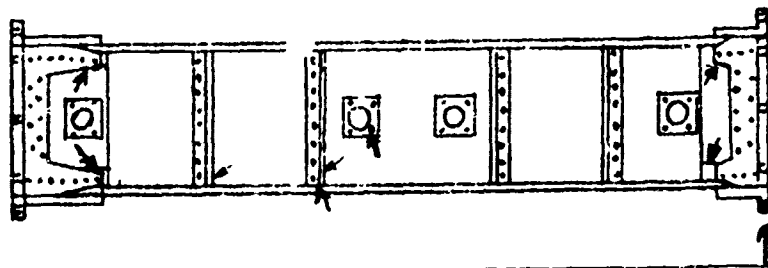
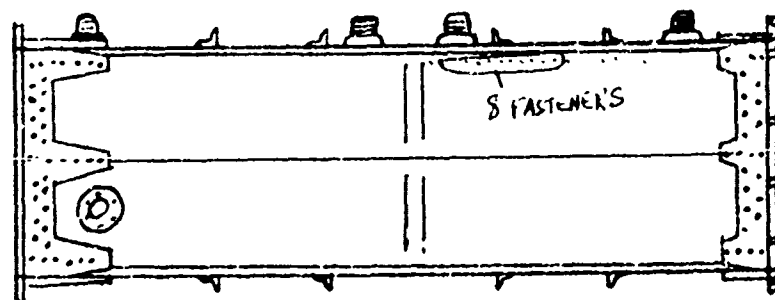
TANK NO. 1 - LEAKAGE AFTER 127 HOURS ENV. CONDITIONING
 AT 415 441°F. (LEAKAGE TEST NO. 1)

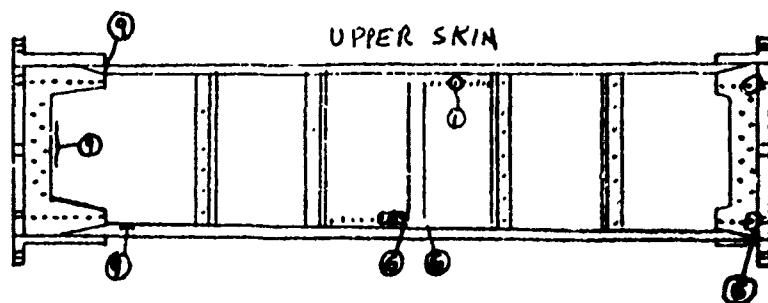
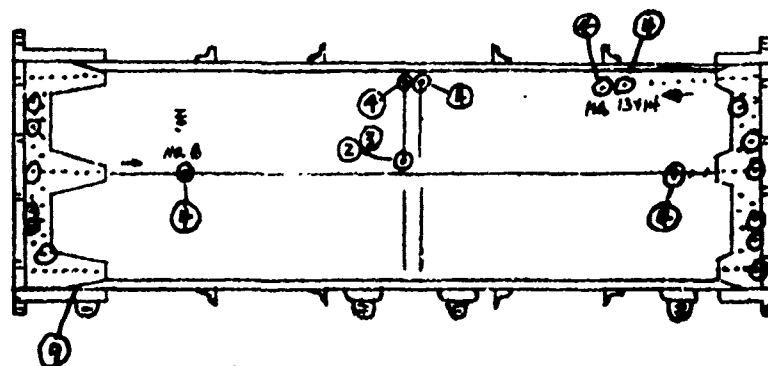
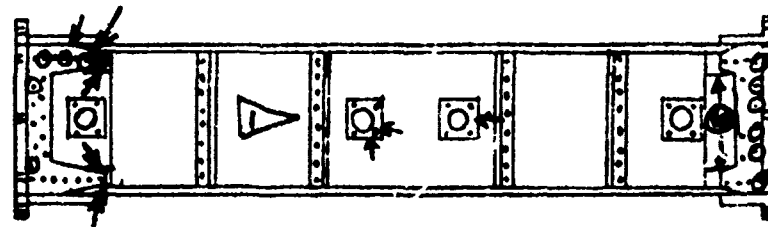
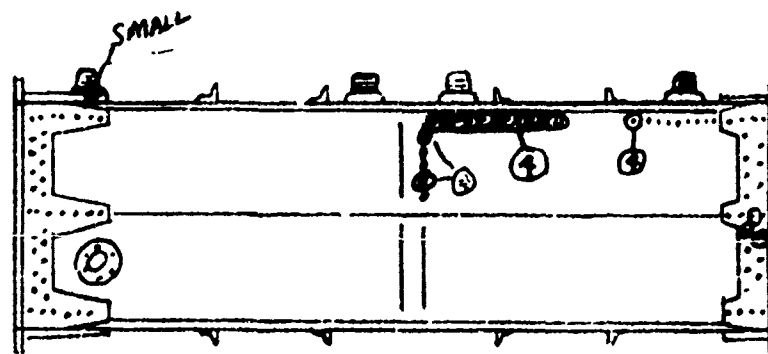
TANK NO. 1 - LEAKAGE AFTER 524 HRS ENV COND. PLUS 510 LOAD
CYCLES AT 426-441°F. (LEAKAGE TEST NO. 2) PAGE A-5

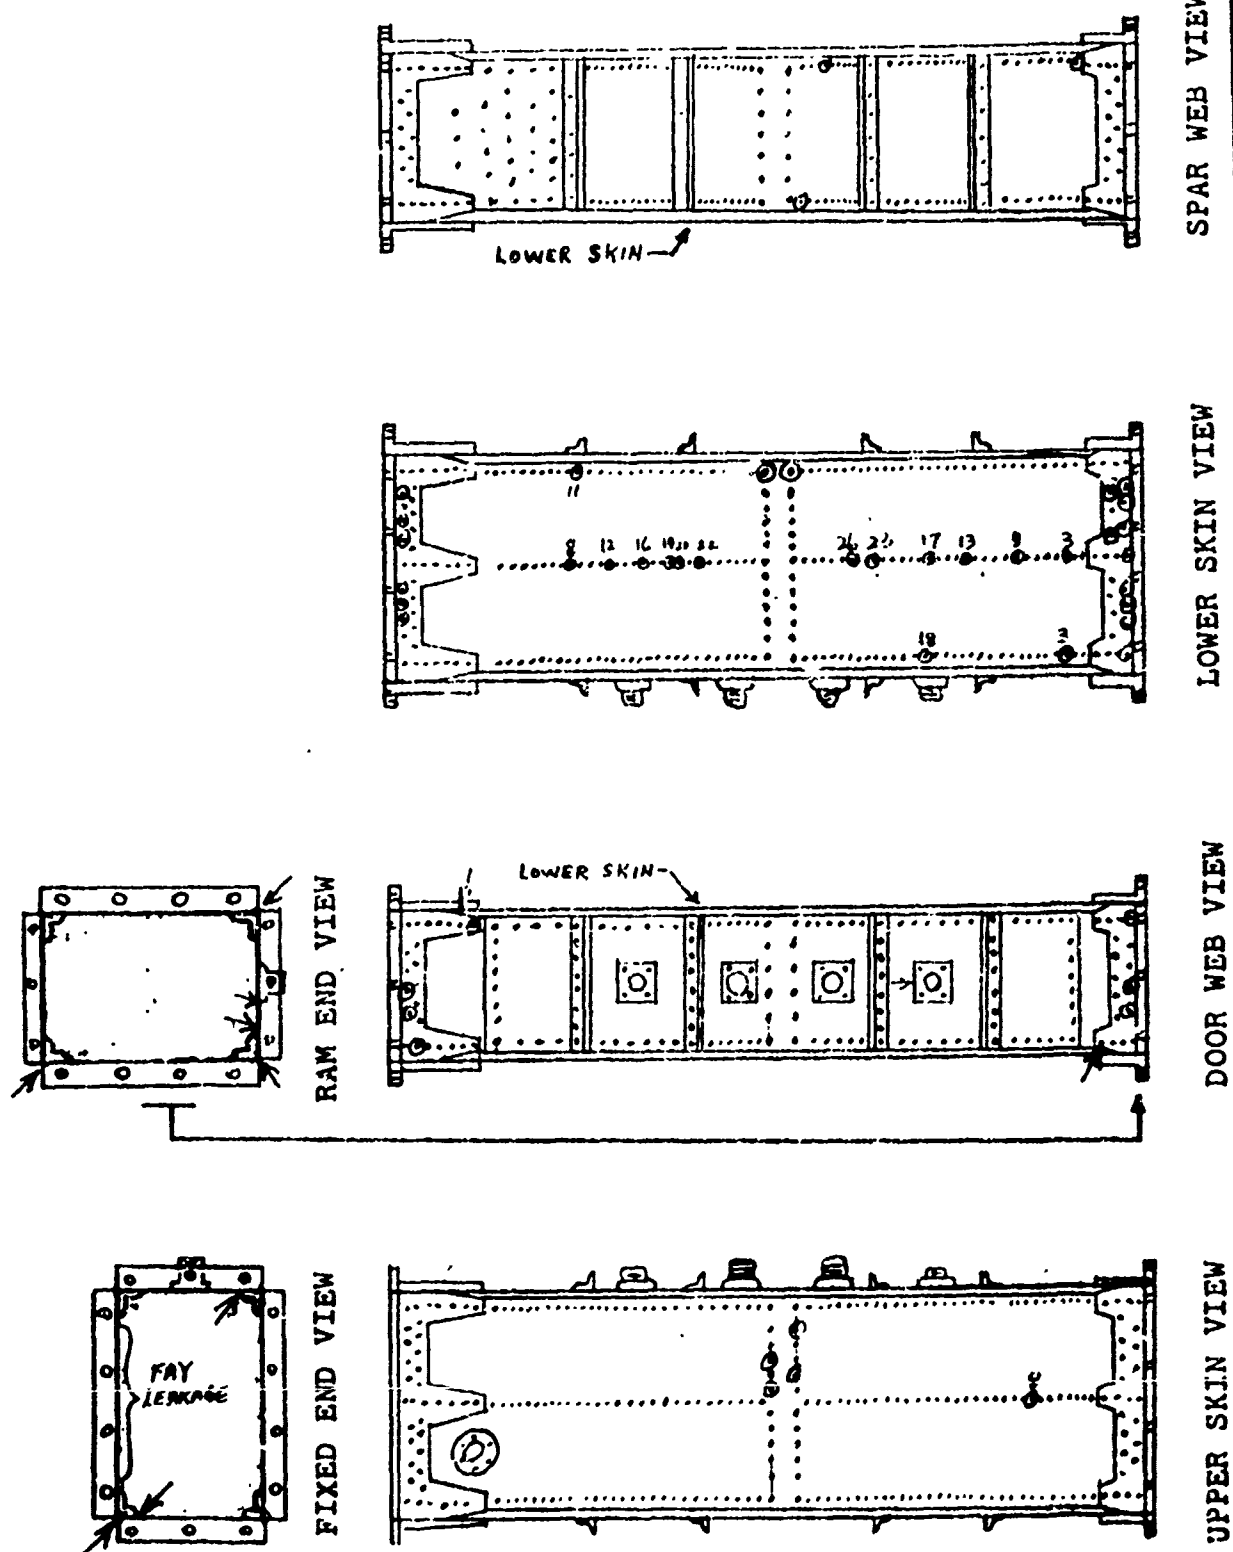
TANK NO. 1 - LEAKAGE TEST NO. 3 (AFTER REPAIRS PER 6.1)

NOTE: LEAK CHECK WAS INCOMPLETE DUE TO TANK BEING ON TEST JIG, AND WET FUEL MADE SOAP SOLUTION INEFFECTIVE. ENDS NOT CHECKED.

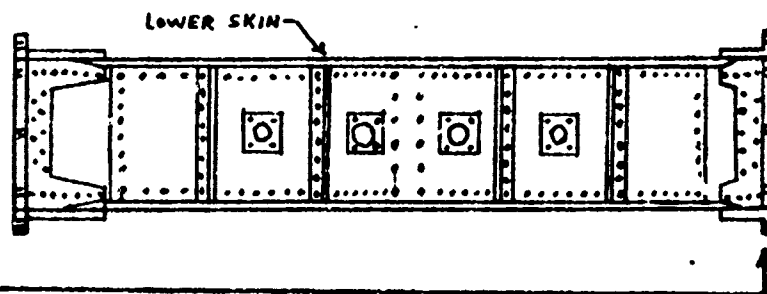
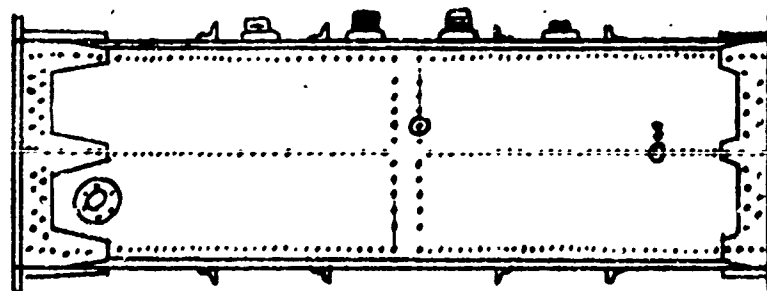
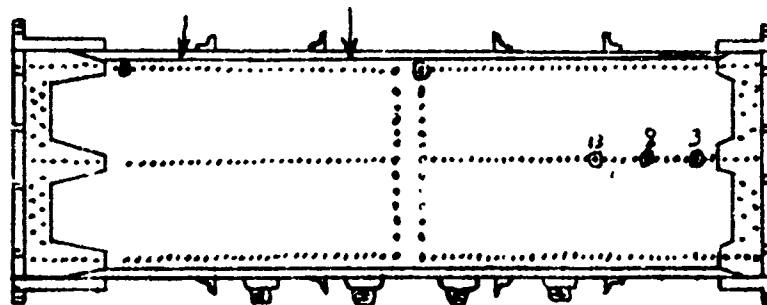
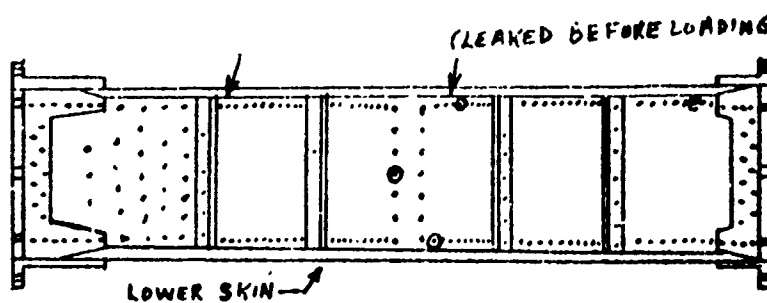
TANK NO. 1 - LEAKAGE TEST NO. 4 (COLD AND ROOM TEMP. CYCLING FOLLOWING REPAIRS PER 6.1)

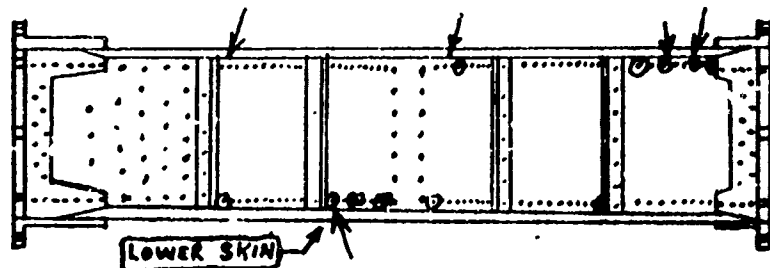
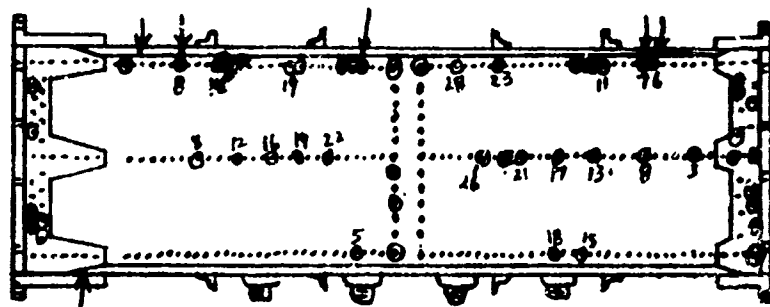
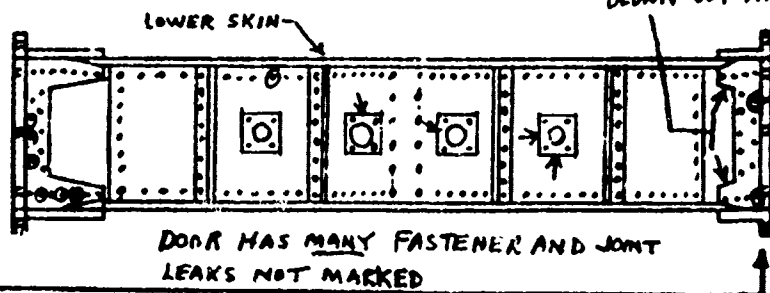
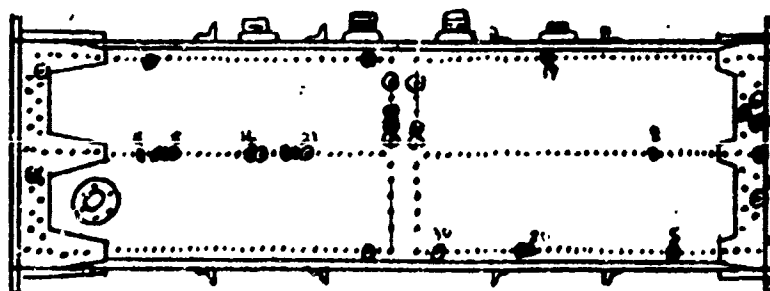
TANK NO. 1 - LEAKAGE TEST NO. 5 (50 LOAD CYCLES HOT, AFTER REPAIRS)

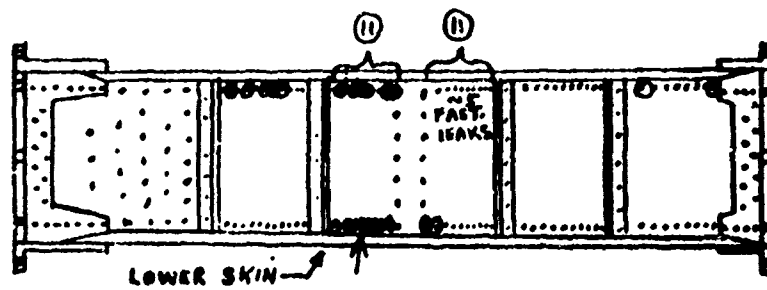
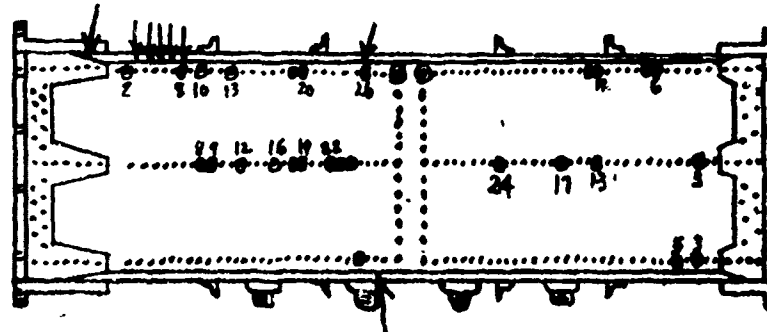
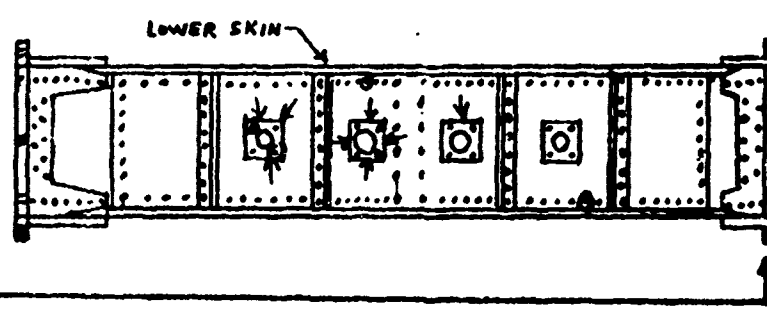
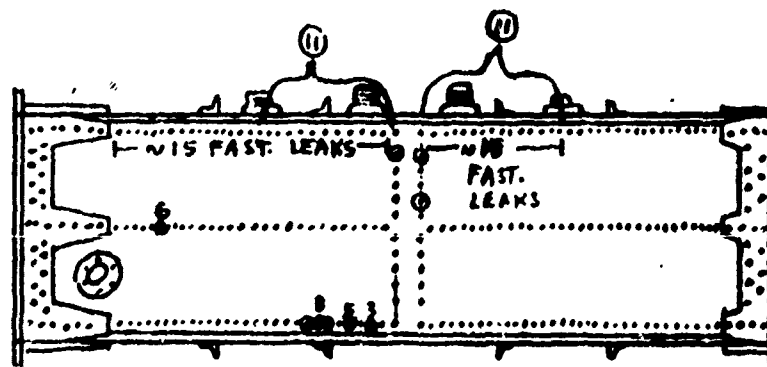
TANK NO. 1 - LEAKAGE TEST NO. 6 (AFTER 1572 HOURS ENV. COND. AT 415-441°F)

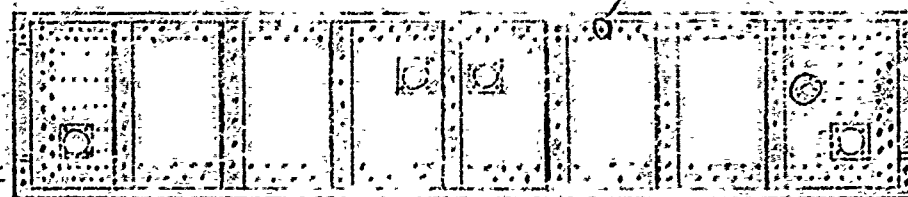
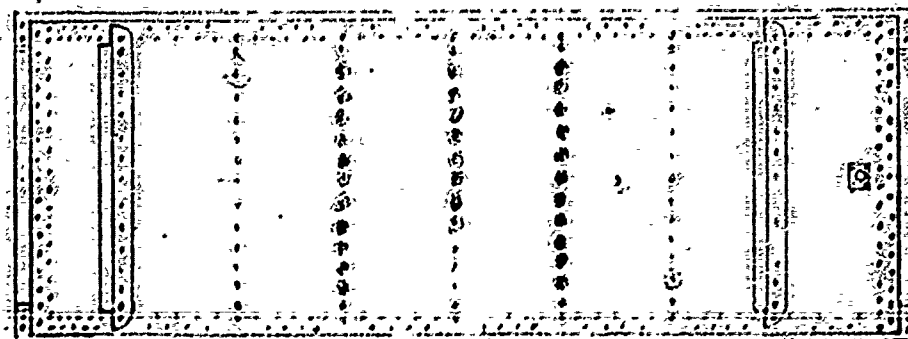
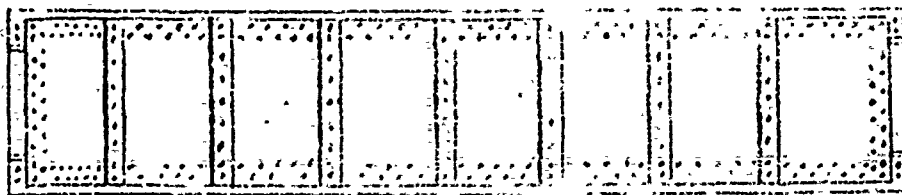
SMALL FASTENER LEAK

CALC		REVISED	DATE	TANK NO. 3 LEAKAGE TEST NO. 1	
CHECK				ORIGINAL LEAK TEST - PRIOR TO ANY	
APR				TESTING AT YAGITA	
APR					
CONTRACT NO.				DATA SHEET NO. 3-1	PAGE 1

HOLE LEAKS WHERE FASTENER WAS MISSING (BROKE OFF DURING CYCLIC LOADING)

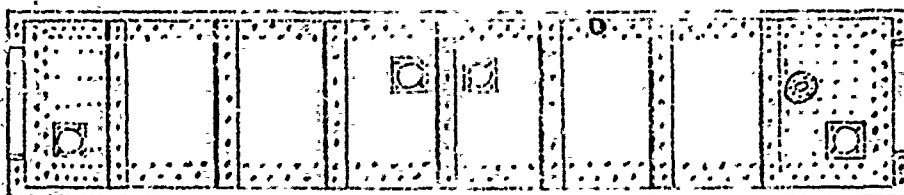
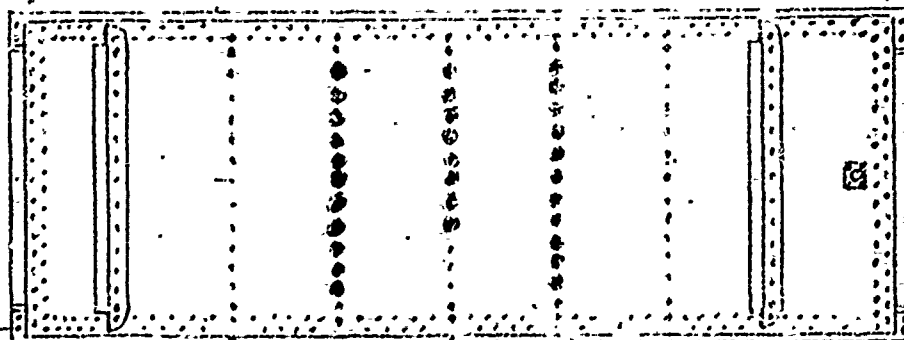
TWO SMALL JOINT
LEAKS

CALC			REVISED	DATE	TANK NO. 3 LEAKAGE TEST NO. 2.	
CHECK					LEAK TESTED AFTER INITIAL LOAD	
APR					CYCLING AT ALL 3 TEMPERATURES	
APR					THE SPENCER COMPANY, AIRCRAFT ENGINEERING AND DESIGN	
CONTRACT NO.					DATA SHEET NO. 3-2	PAGE B-2

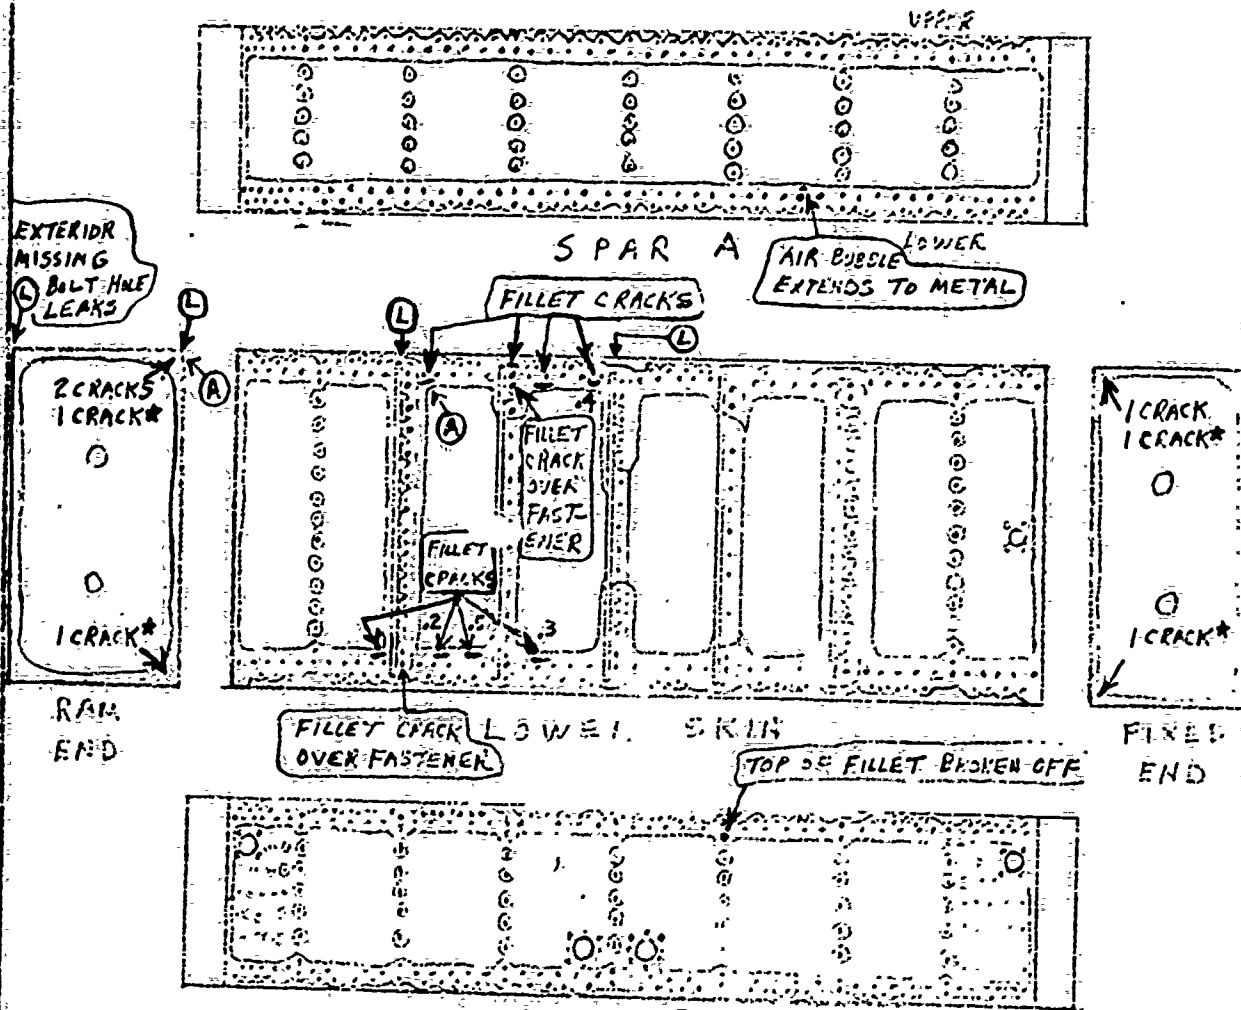
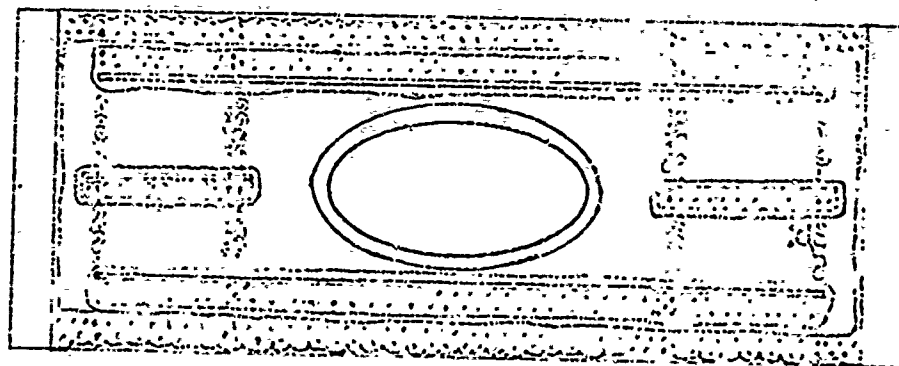
(A) 3 PSIG VACUUM LEAK TEST SHOWED INTERIOR LEAK HERE (BOILING THRU WATER)

NUMBERS INDICATE CRACK LENGTH UPPER SKIN

(L) = EXTERIOR JOINT LEAK

* = MAY BE INCOMPATIBILITY OF REPAIR OVER CURED SEALANT

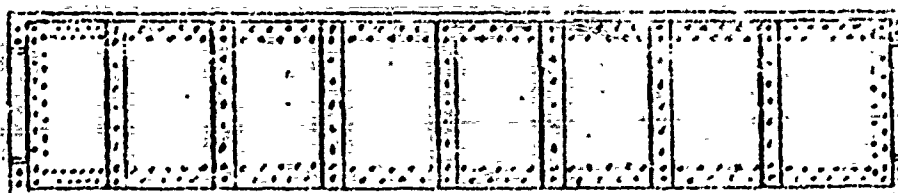
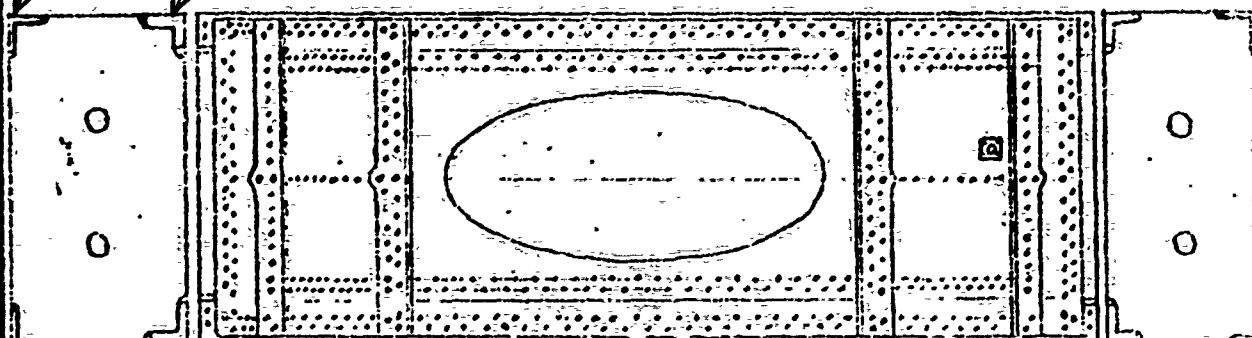
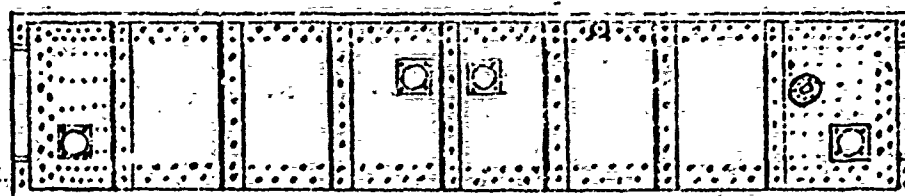
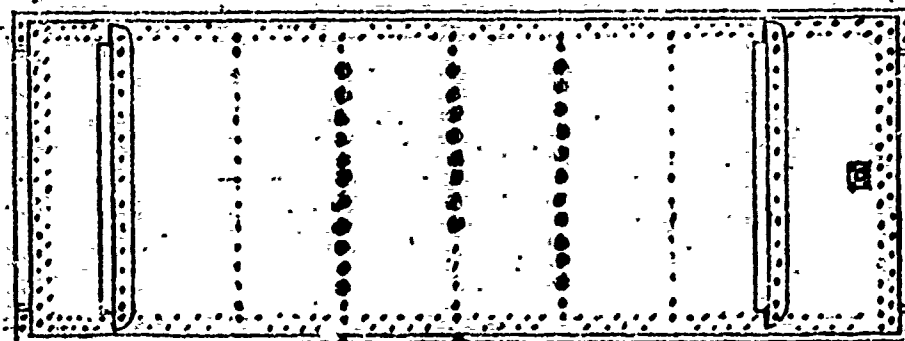
*Previous leak
(had not been
repaired) / Previously repaired but
still leaking*

LOWER SKIN
NEW
LEAK

CALC			REVISED	DATE	TANK NO. 3 LEAKAGE TEST NO. 3. LEAK TESTED AFTER 1500 LOAD CYCLES AT R.T. PLUS 500 HOT CYCLES.	
CHECK						
APR						
APR						
CONTRACT NO.					DATA SHEET NO. 3-4	PAGE B-4

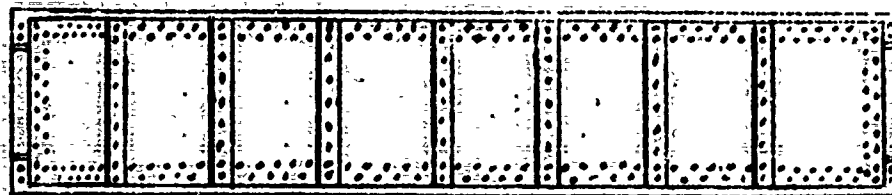
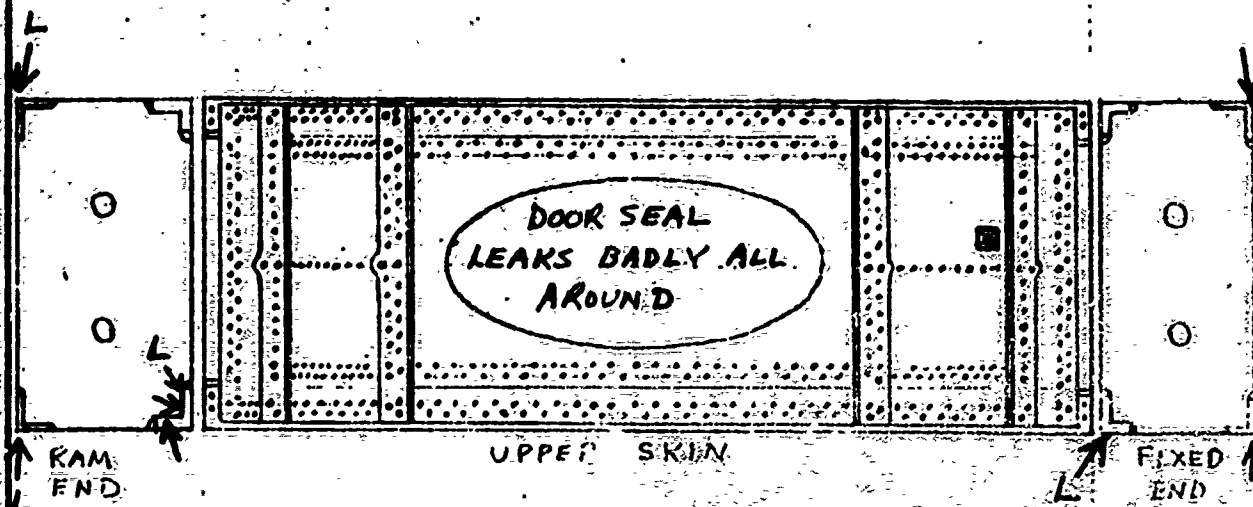
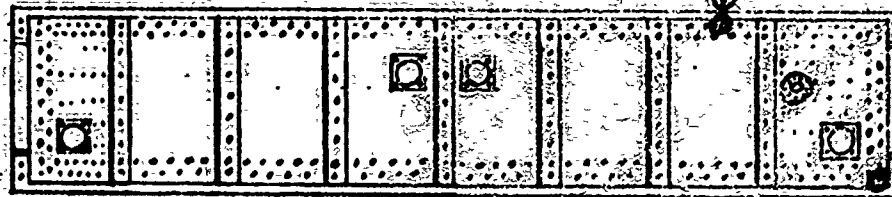
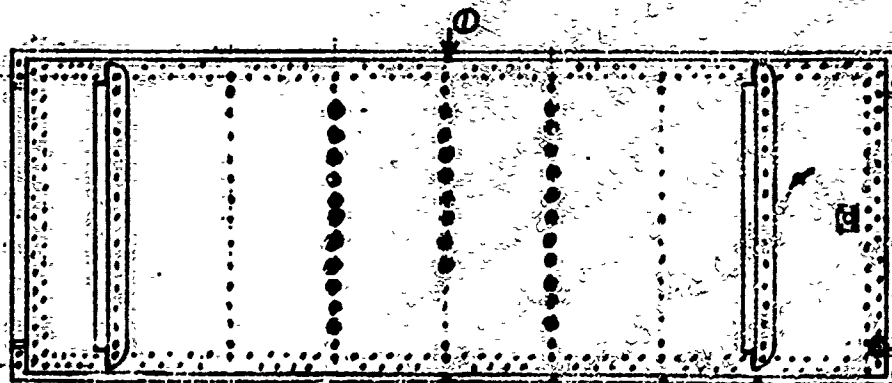
ARROWS INDICATE LEAKS

ADDITIONAL LEAKS DURING SECOND LEAK

CNC	LM	8-6-71	REVISED	DATE	TANK NO. 3 LEAKAGE TEST NO. 4
CHIEF					AFTER 8 ENVIRONMENTAL
APT					CONDITIONING CYCLES
APT

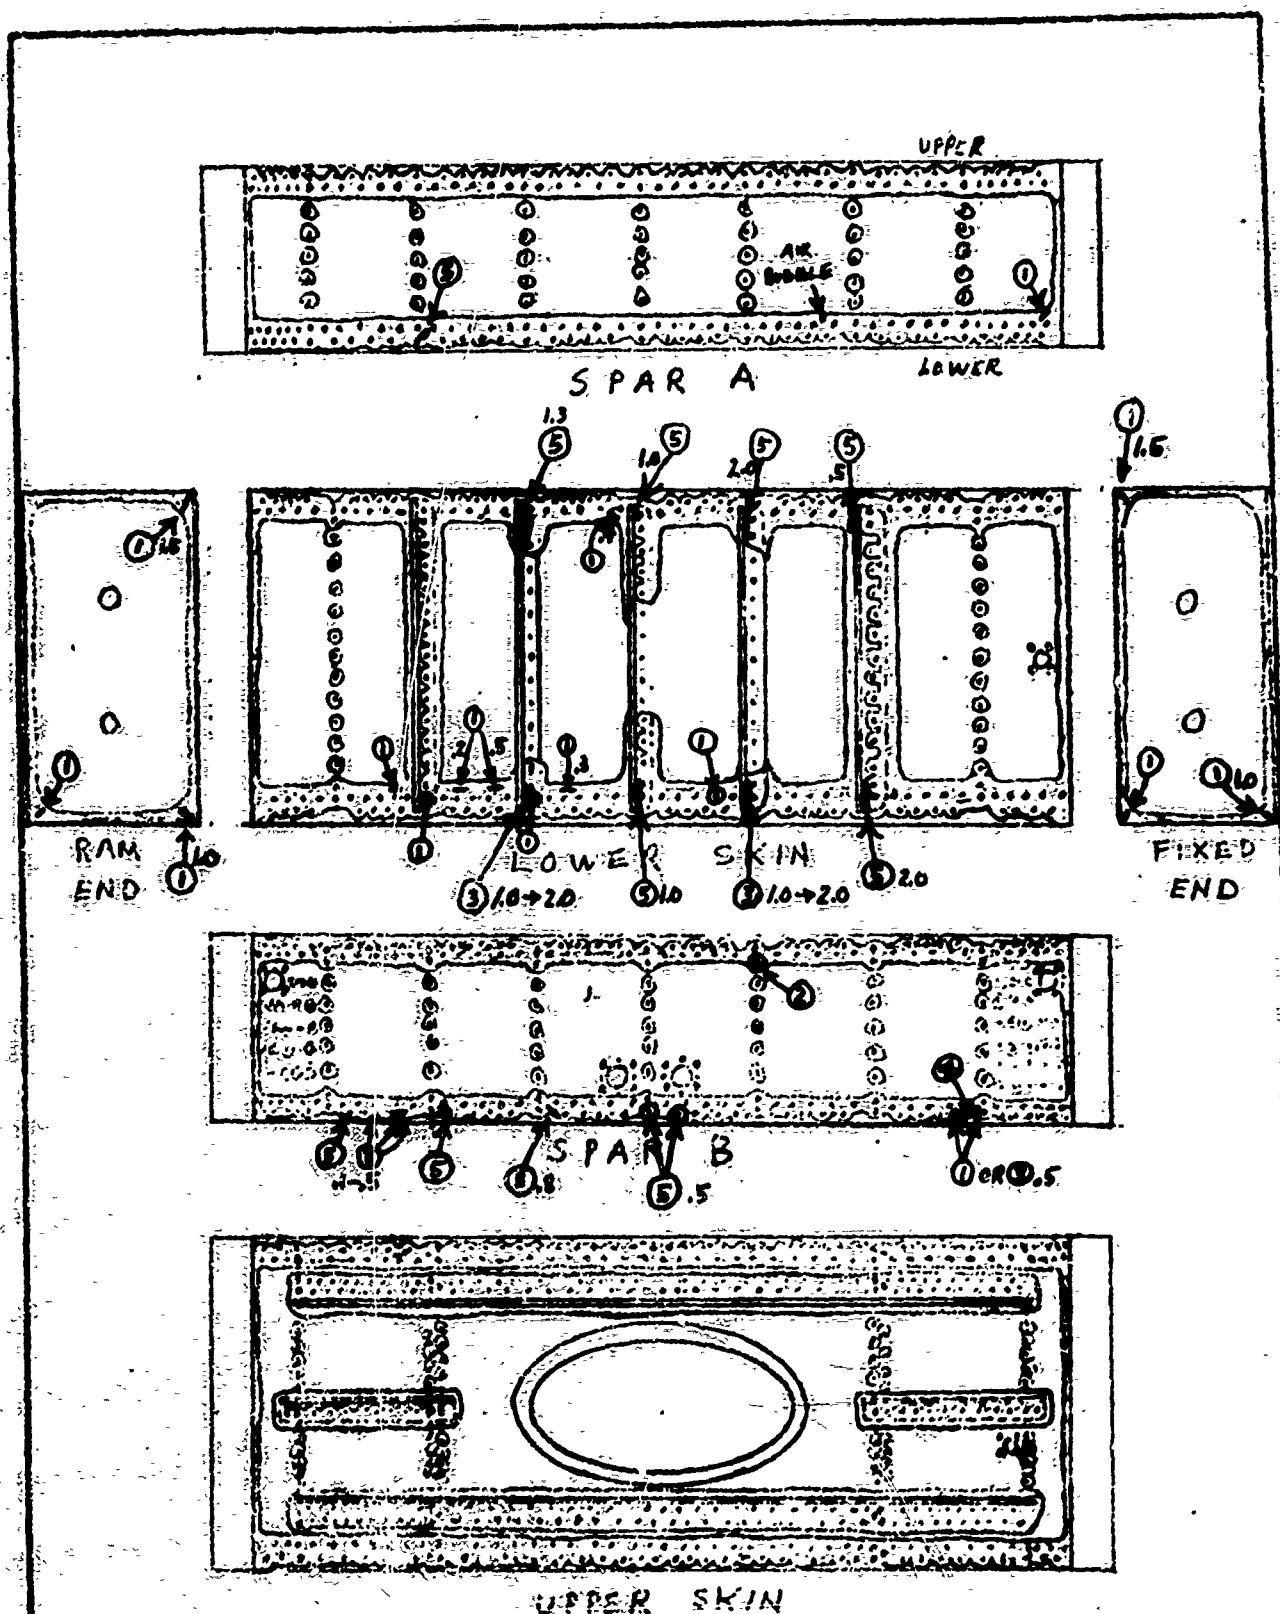
DATE	BY	REVIEWED	DATE	TANK NO. 3 INTERIOR VIEW AFTER 8 ENVIRONMENTAL CONDITIONING CYCLES	
8-6-71

- ① → INDICATES FILLET CRACK (LENGTH AS NOTED IN INCHES)
- ② → FILLET OVER FASTENER PARTIALLY TORN OFF
- ③ → FILLET: CRACKS THAT LENGTHENED WHEN TANK WAS DRIED OUT (16 HRS @ 310°F) ON AUG 5 TO PREPARE FOR REPAIRS.
- ④ → LOSS OF ADHESION
- ⑤ → NEW FILLET CRACKS WHICH DEVELOPED DURING AMBIENT STORAGE (BETWEEN 6 APRIL AND 6 AUGUST 1971) OR WHEN TANK WAS DRIED OUT (16 HRS @ 310°F) ON AUG 5, 1971 TO PREPARE FOR REPAIRS.

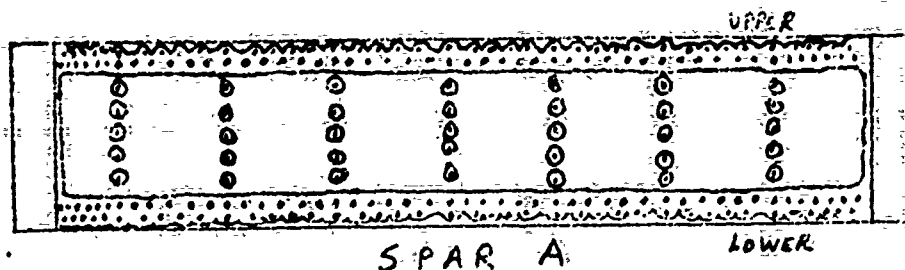
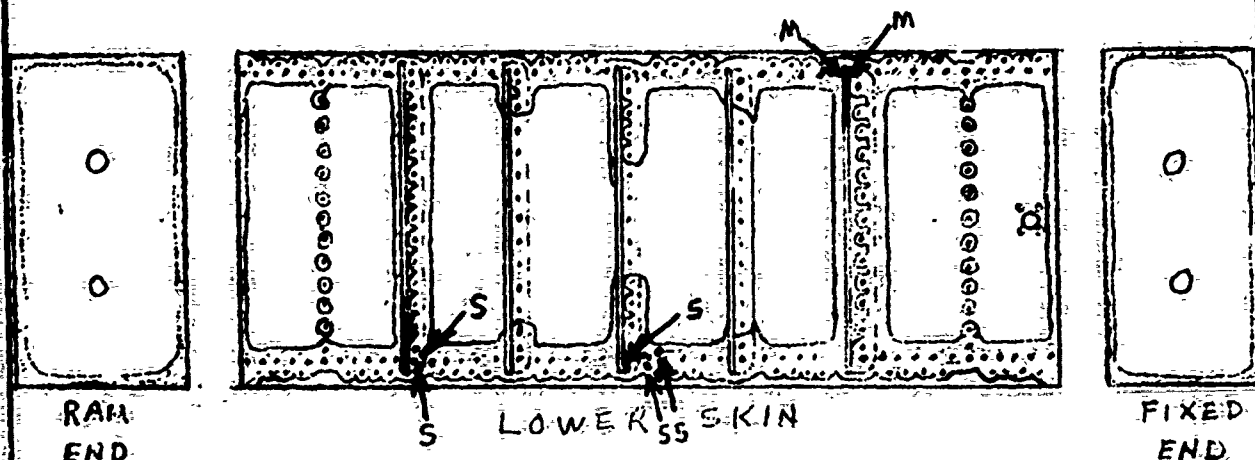
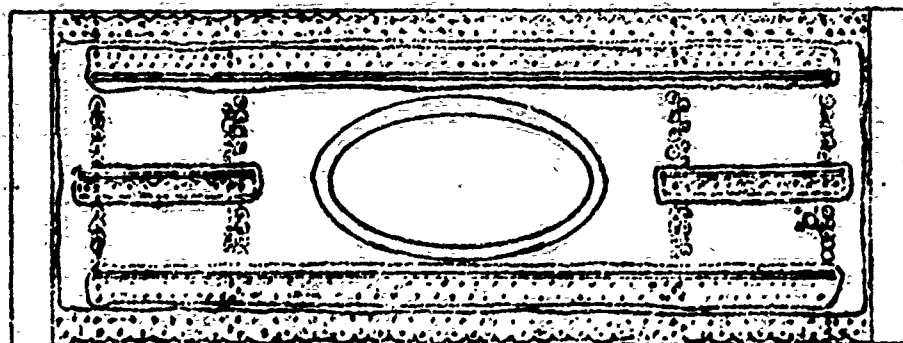
L-LARGE LEAK (RAPID BUBBLING) UPPER SKIN

INTERIOR LEAKAGE WITH 3 PSI VACUUM

CNC	DATE	REVISION	DATE	TANK NO. 3 INTERIOR VIEW	
				LEAKAGE AFTER 16 HRS DRY OUT	
				AT 310°F.	
				THE BUREAU COMPANY	
				MEMPHIS DIVISION - MEMPHIS, TENN.	
					PAGE
					B-9

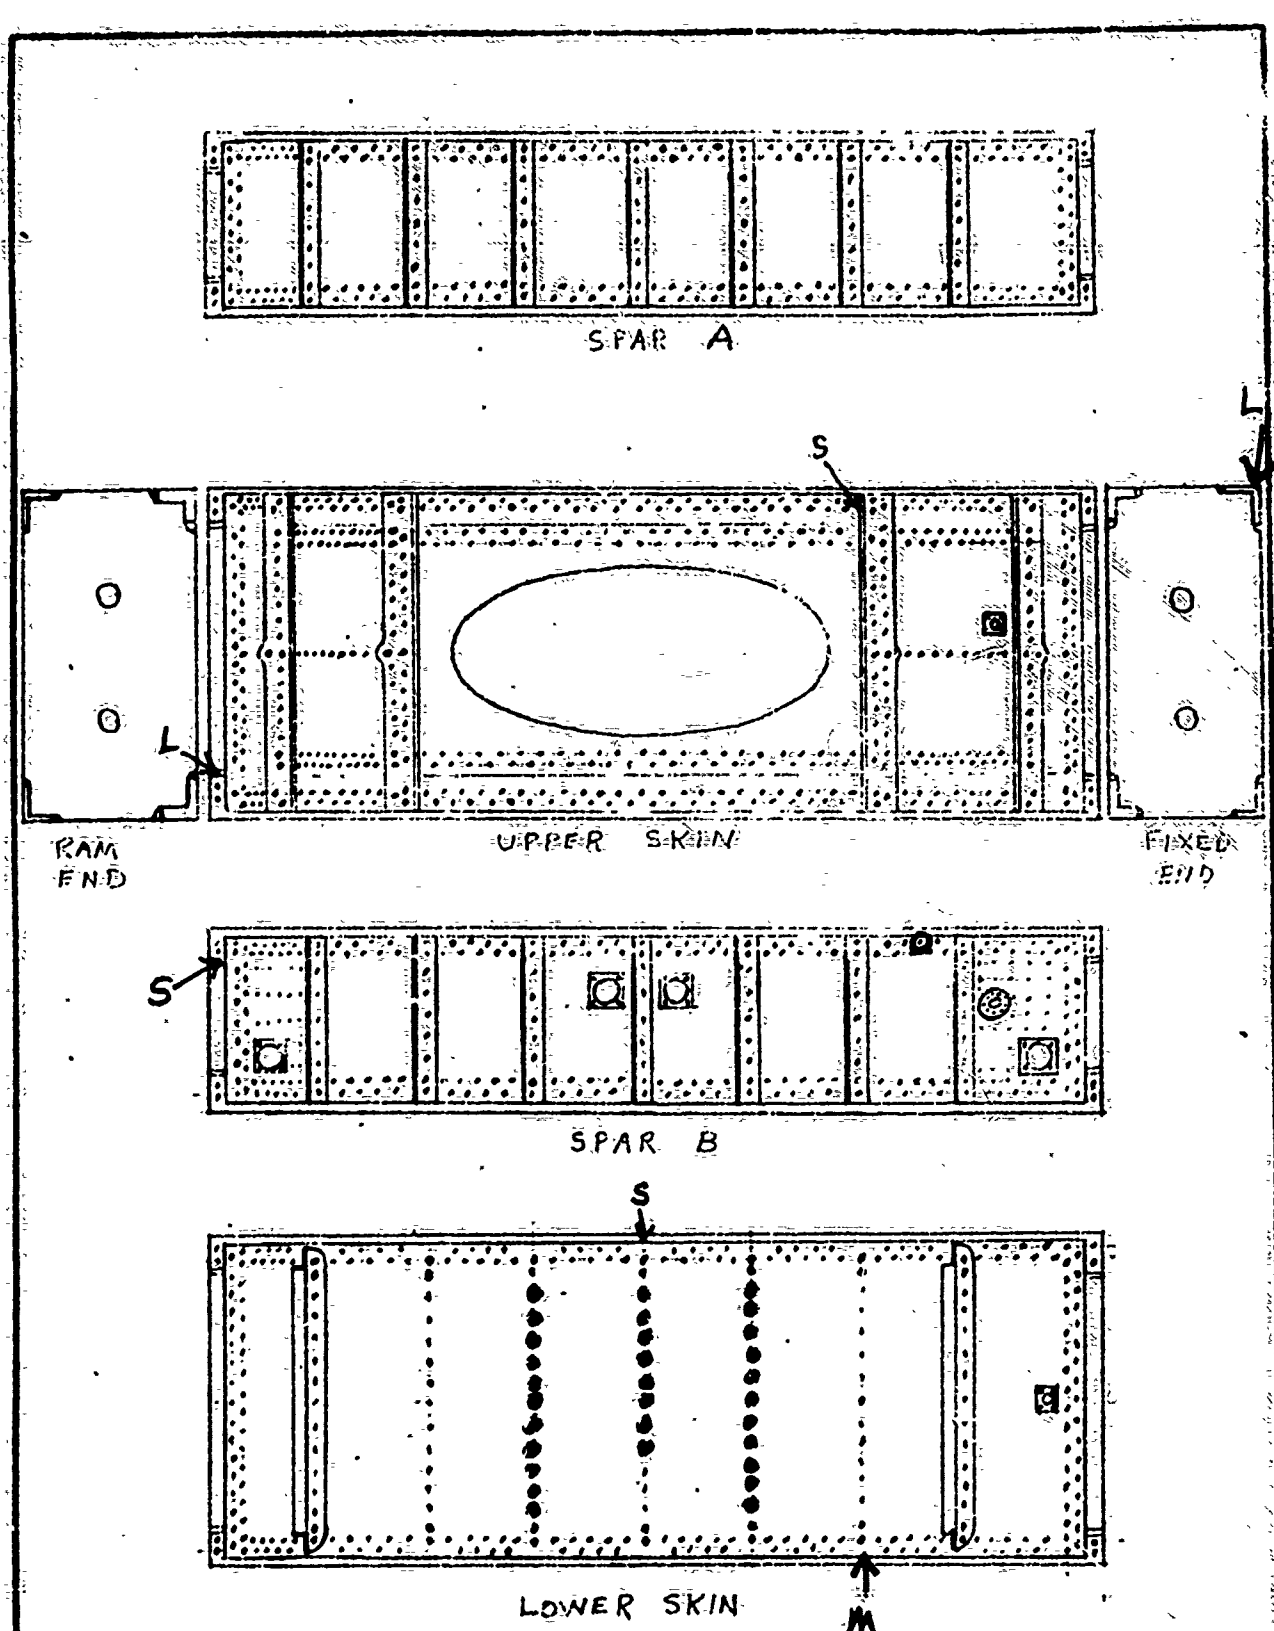
CALC			REVISED	DATE	TANK NO. 3 LEAKAGE TEST NO. 5
CHECK					AFTER REPAIRING 6 LEAKING CORNERS
APR					
APR					
THE BOEING COMPANY AIRPLANE DIVISION - WICKIUS DIVISION					PAGE B-10
CONTRACT NO.

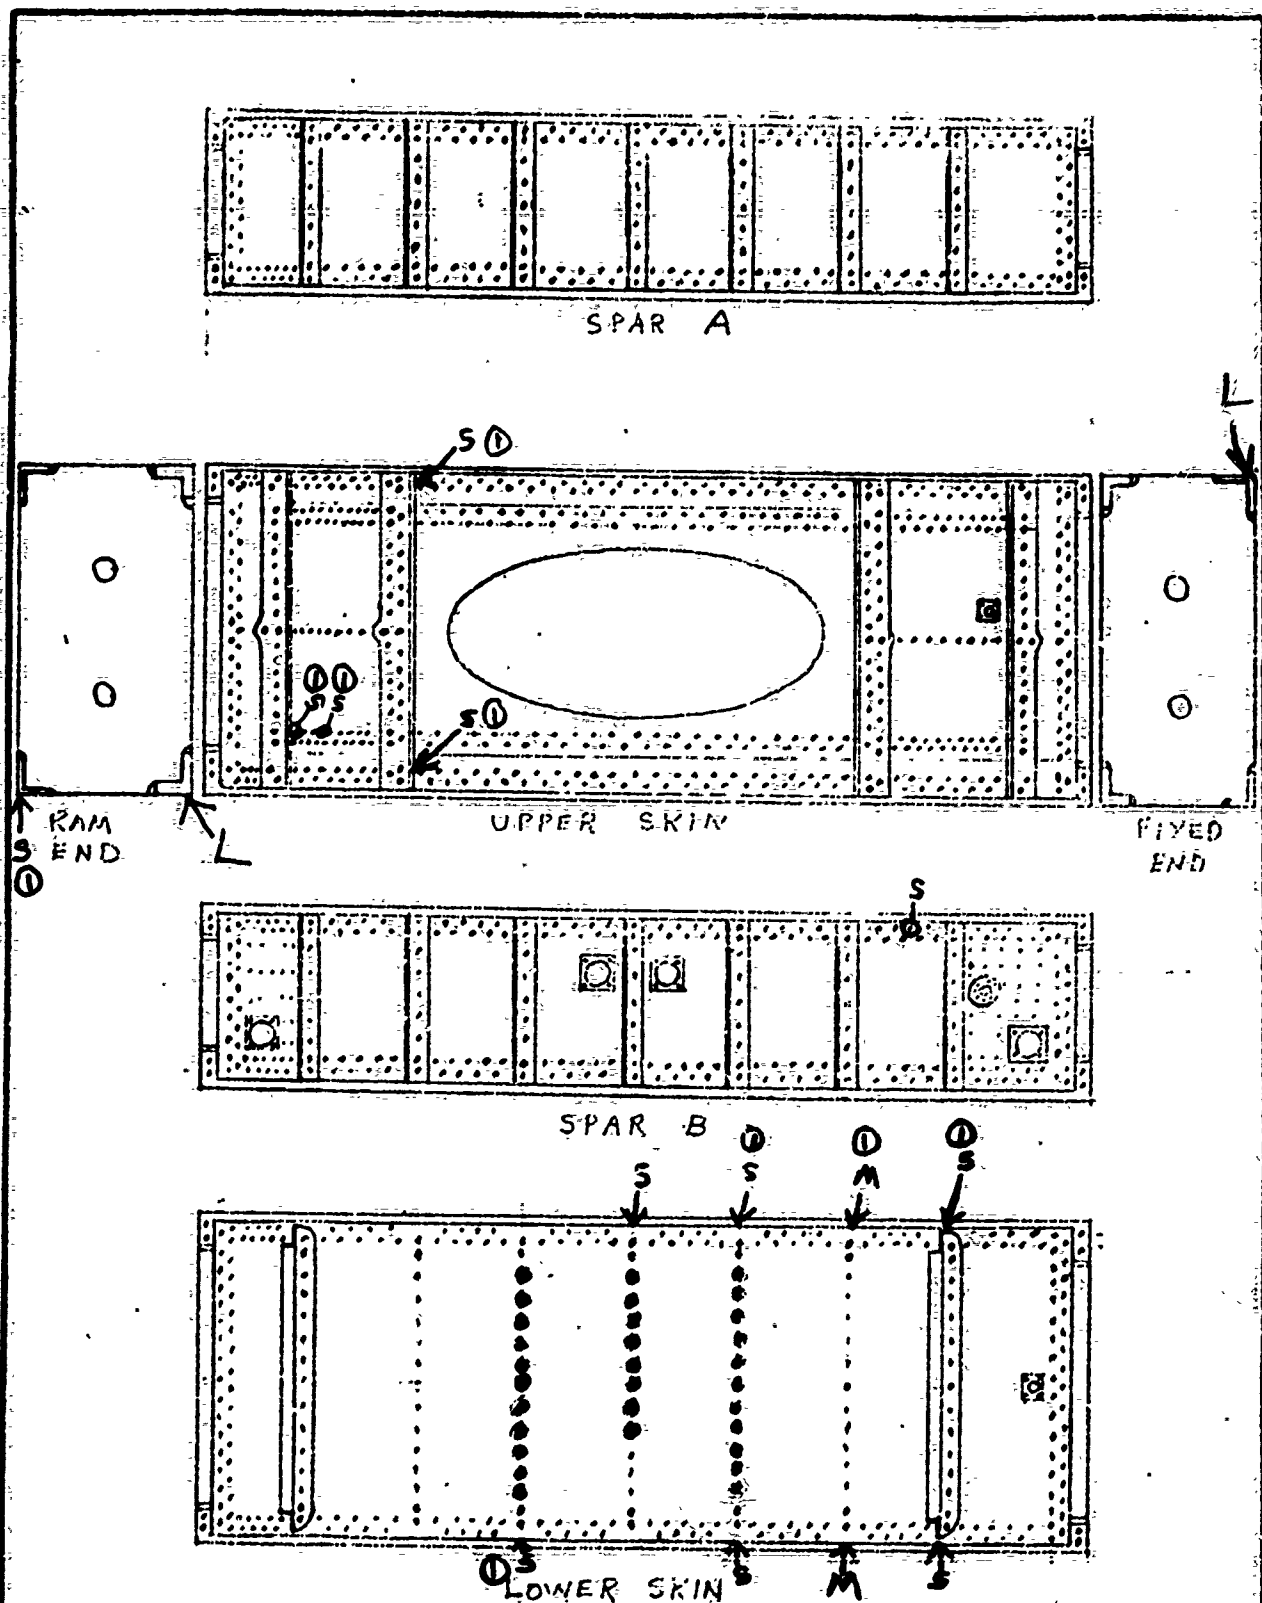
① - NEW LEAKS THIS TEST

TANK NO. 3 LEAKAGE TEST NO. 6
AFTER LOAD CYCLING AT THREE
TEMPERATURES (FOLLOWING 8 CYCLES)
